The capsular attachment of the ulnar coronoid process: an MRI arthrography study

Robert Ablove^a, Rick Kijowski^b, Brian Grogan^a and Rachel Loomans^a

ABSTRACT

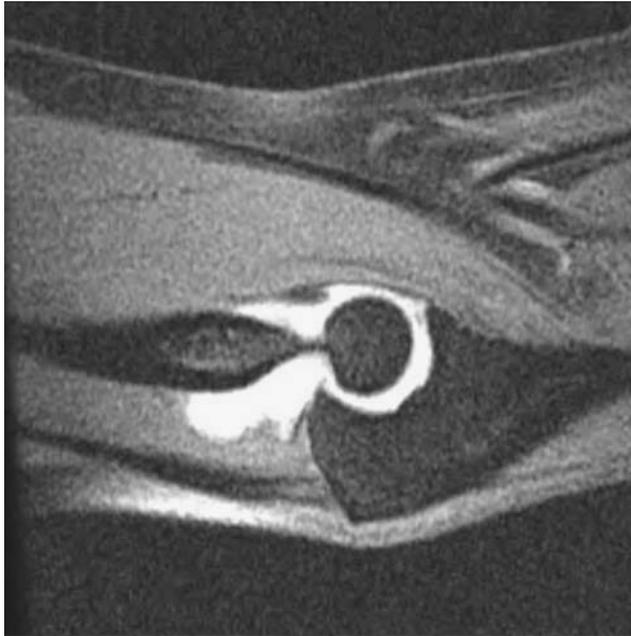
FIGURE 1. An example of a sagittal MRI arthrogram at peak coronoid height demonstrating a capsular insertion at the tip of the coronoid process.

The study was performed in compliance with HIPAA regulations and with an exemption from our Institutional Review Board. Twenty-one consecutive magnetic resonance (MR) arthrograms of the elbow were selected from a database of MR examinations performed at our institution between January 1, 2001 and December 31, 2008. One was excluded because of evidence of osteoarthritis. The remaining MR arthrograms of the elbow were performed on 20 patients (thirteen males and seven females; age range between 14–57 years; average age of 30.4 ± 14.2 years) for various reasons, including evaluation for epicondylitis, medial ulnar collateral ligament integrity, and osteochondritis dissecans. No patient had a history of elbow fracture or osteoarthritis of the elbow joint (Figure 1).

The sagittal fat-suppressed T1-weighted fast spin-echo images of all 20 MR arthrograms of the elbow were reviewed on an ALI workstation (Horizon Medical Imaging Systems, Version 5, McKesson Corporation, San Francisco, California) by a fellowship-trained musculoskeletal radiologist. The distance between the tip of the coronoid process and the attachment site of the anterior joint capsule onto the coronoid process was measured using electronic calipers. The attachment site of the anterior joint capsule was well visualized on the MRI because of distension of the joint capsule with intraarticular contrast. The height of the coronoid process on a perpendicular axis relative to a line drawn from the articular surface of the ulna to its anterior cortex also was measured using electronic calipers.
